# Windermere By-the-Lake

## Site Walkabout

June 4, 2002, 6 – 7:30 pm

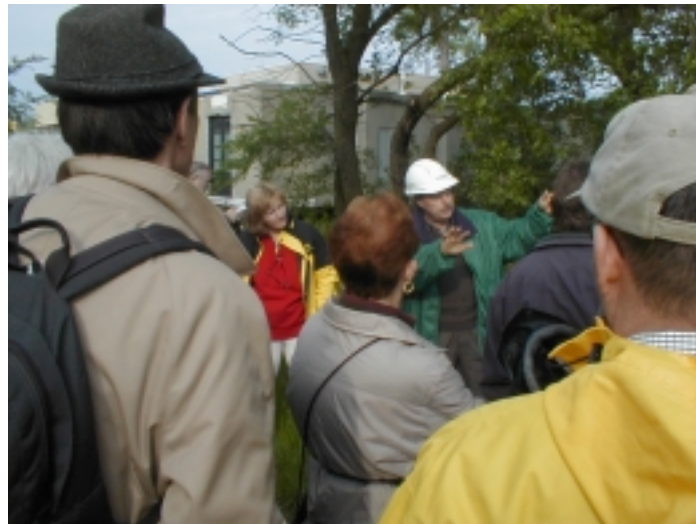
### **First Stop - Ellis and Queensway Corner:**

- A stream emanating from Grenadier Pond runs under the Queensway and onto the East Site, where it emerges above ground for some distance near the eastern corner. This area will be turned into a public access park, and will preserve the waterway and incorporate it into the design.

- A berm, approximately two meters high, will be built along the length of the railway line.
- The pumping station situated on the Queensway is City property and will stay.

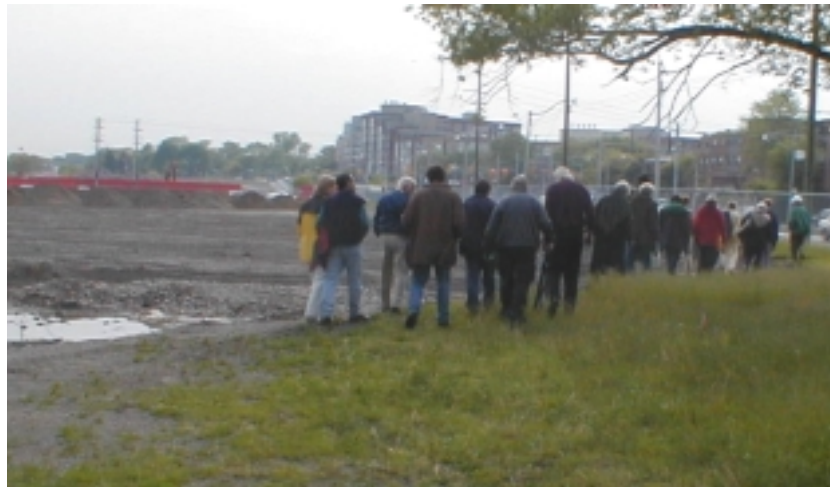
### **Second Stop – Midway on East Site:**

A fifteen metre grid has been laid out over the entire site, and bore-holes drilled at each node, to test for contaminants. They anticipated that two different types of contaminants were likely to be found, on the site: metals (like cadmium, arsenic, zinc, etc.) or petroleum hydrocarbons. Metals found on the East Site were from slag which was brought in as fill in the early 1900s, since the land was originally swamp and lowlands. Samples were tested by chemical analysis, the slag removed, and clean fill was brought in to raise the land level.

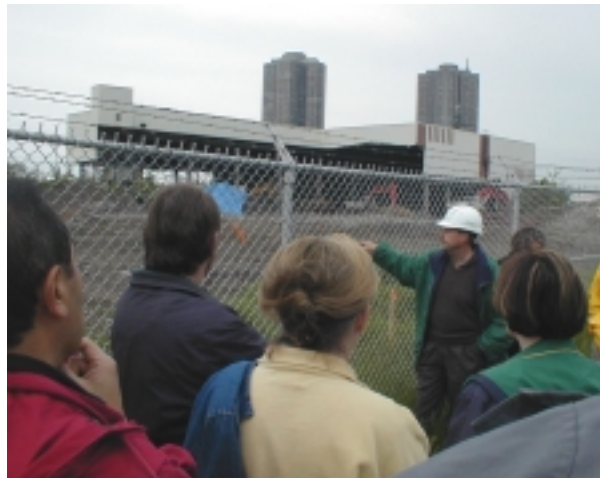
#### **Fifth Stop - Midway on West Site**

- A 15 metre grid for verification sampling was used on the West site as well. Samples from the nodes are tested at outside labs. However, there are field testing facilities in the trailer as well, which are used for immediate analysis as required, in order that the work can move forward. The offsite lab can take two weeks to produce results, since it serves other clients as well, and is not dedicated to the immediate needs of REON. However, results from the on-site testing lab are calibrated against the off-site lab results, and all samples that are used for the required reporting are sent to the off-site laboratory for confirmatory testing.
- Two highrises will be built on the West Site. Between them, and at the far west and the southeast of the site will be parks. Behind them will be a landscaped berm.

- There is ongoing dust and odour monitoring. Internal site roads are watered down when it is dusty. An odour can occur when opening up new excavations.
- Groundwater levels are monitored regularly throughout site operations to ensure there is no impact on the water table.
- Reinforcing steel in the concrete floor slab is separated from the concrete during the crushing process, and is reclaimed as scrap metal.
- The big building remaining on the site is still standing because the demolition company wants to sell it as an intact building before removing it from the site. REON is eager to get rid of it, and will ensure that it will be gone within about three months.
- The hydro transformer on the far west side of the West site is not part of the REON site, and cannot be removed. REON will landscape around it, to minimize its visual impact.
